Manhole Inspection Summary

Manhole # S51II_011MH

Insp Date: **8/7/08 8:31 AM**

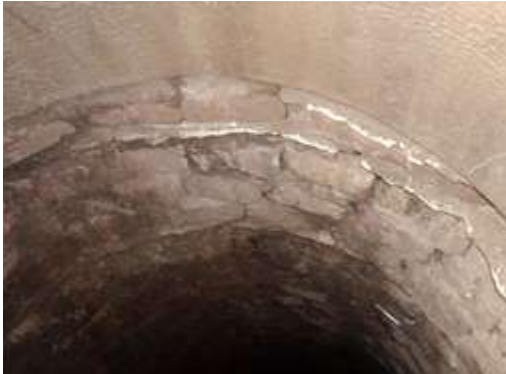
Defect 1

Infiltration: ☐ None ☐ Joint ☐ Cracks ☒ **Mortar** ☐ Roots ☒ **Wall**

Infiltration

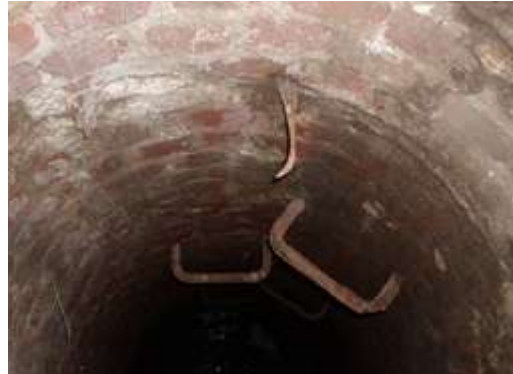
Defect 2

☒ **Leaks**

Frame leaks

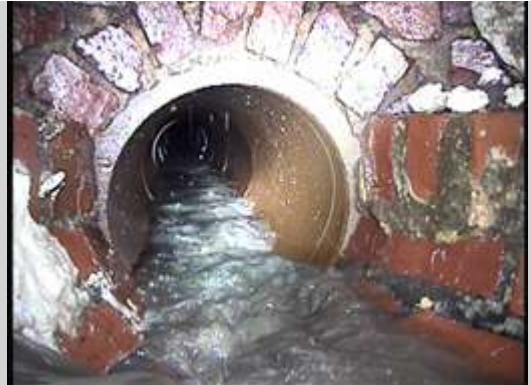
12 O'Clock Outflow

15 in. Circular Gravity Sewer
Pipe Out @ 12 O'Clock

Pipe Height: **15.6** (in.) Rod and Bar (Angled)
Pipe Material: **Clay** ☐ Pipe Lined
Invert Depth: **17.30** (ft.) Flow Characteristics: **Fast**
Deposits: ☒ None ☐ Mud ☐ Sludge ☐ Debris ☐ Grease
Silt Depth: (in.) Deposits Extent:
Infiltration: **None** Pipe Seal Cond: **Sound**

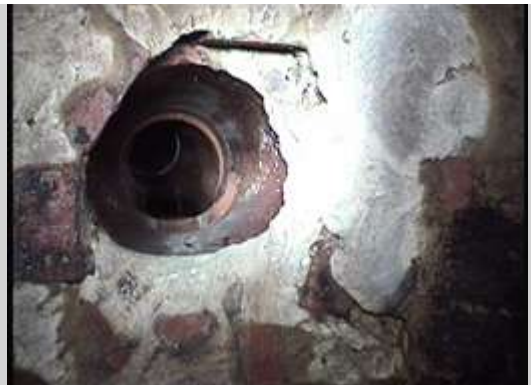
3 O'Clock Inflow

8 in. Circular Gravity Sewer
Pipe In @ 3 O'Clock

Pipe Height: **8.4** (in.) Rod and Bar (Angled)
Pipe Material: **Clay** ☐ Pipe Lined
Invert Depth: **9.20** (ft.) Flow Characteristics: **Fast**
Deposits: ☒ None ☐ Mud ☐ Sludge ☐ Debris ☐ Grease
Silt Depth: (in.) Deposits Extent:
Infiltration: **None** Pipe Seal Cond: **Sound**

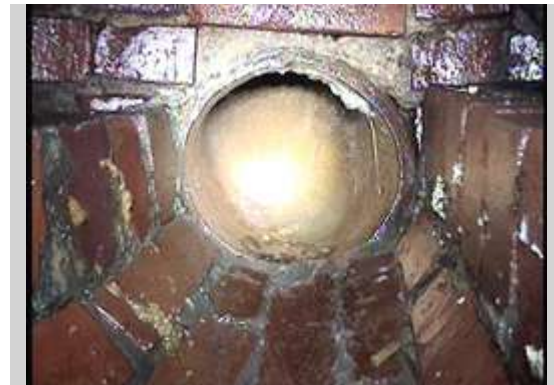
Drop In @ 3 O'Clock

Drop: **Inside** Rod and Bar
Angled: **Yes** Reading: **15.90** (ft.)
Inv Depth: **16.90** (ft.)

Drop Condition: **Open**

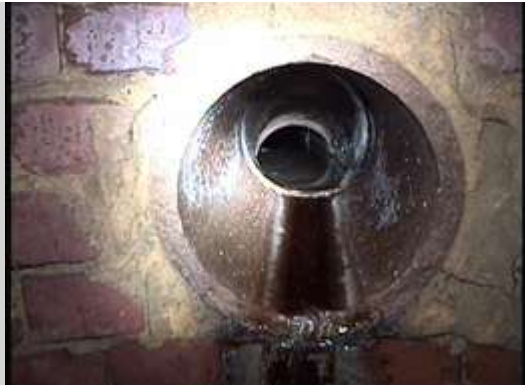
6 O'Clock Inflow

Pipe In @ 6 O'Clock

Infiltration: **None** Pipe Seal Cond: **Sound**

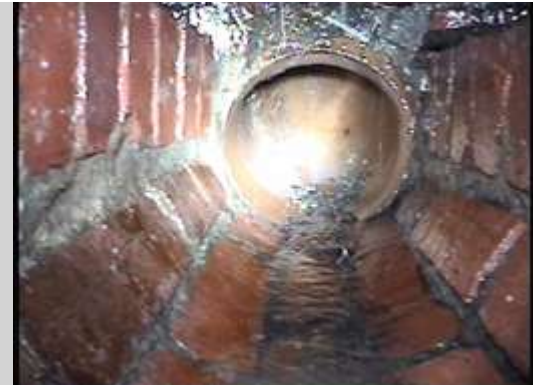
Drop In @ 6 O'Clock

| Drop: Inside | Rod and Bar |
| Drop Condition: Open | |

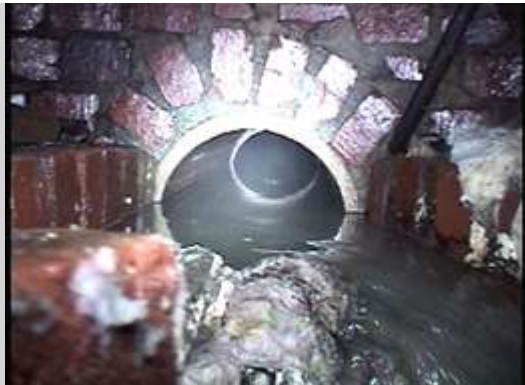
9 O'Clock Inflow

Pipe In @ 9 O'Clock

Infiltration: **None** Pipe Seal Cond: **Sound**
